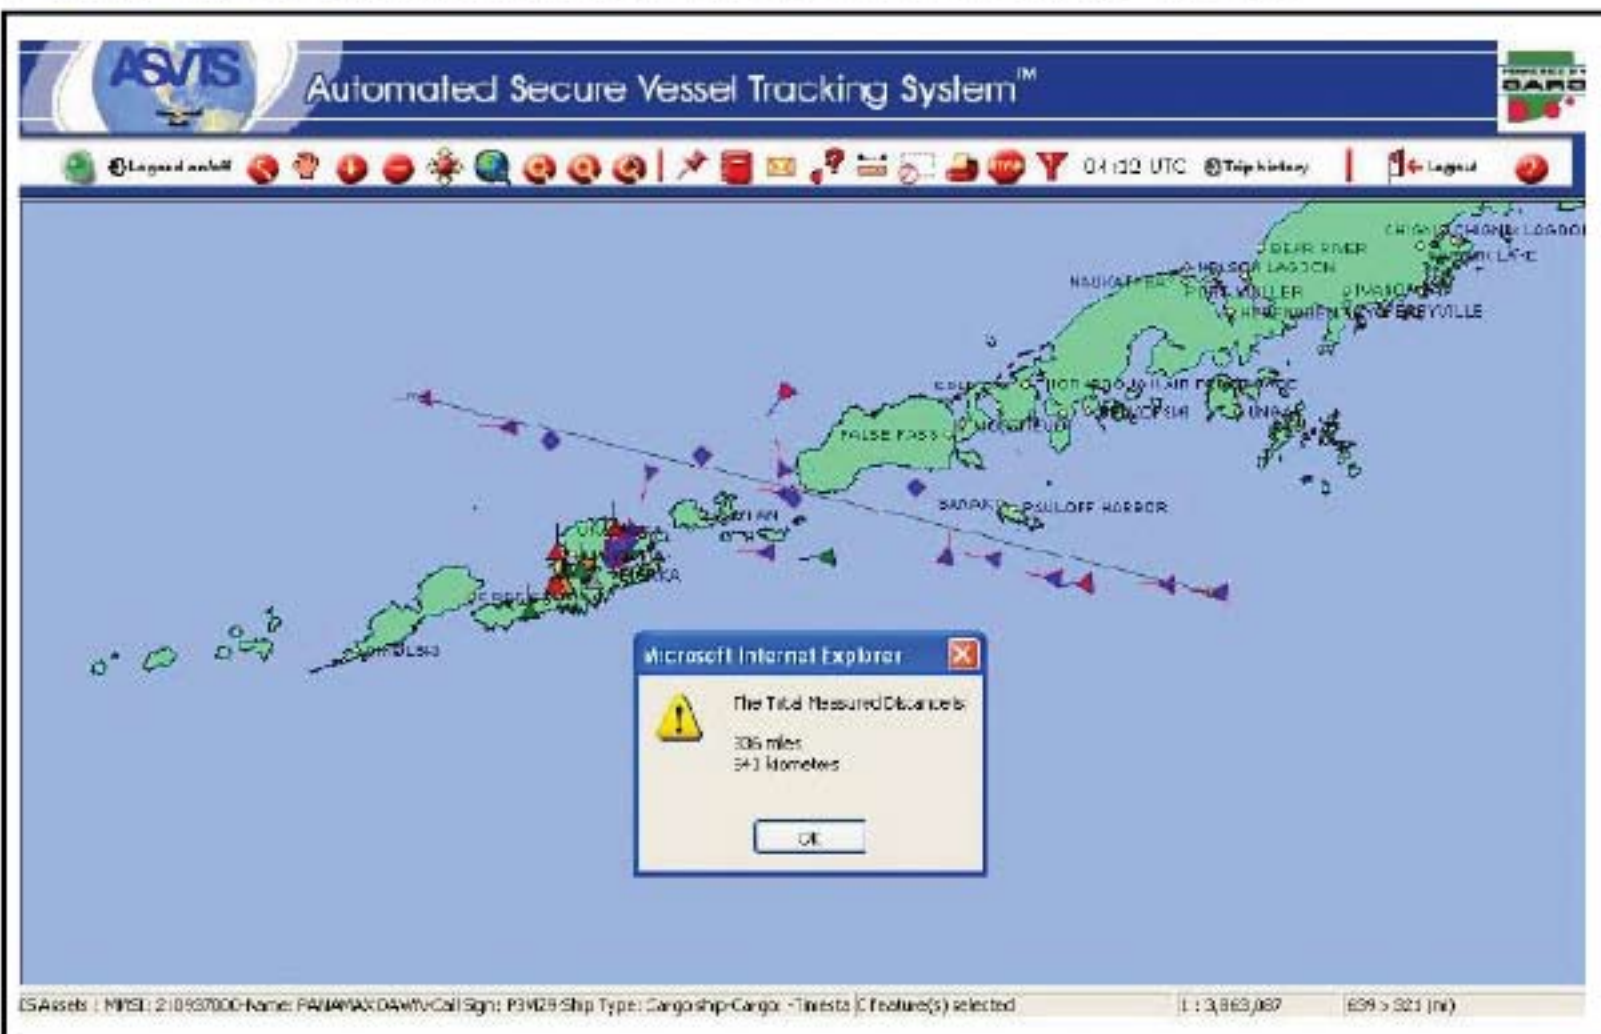
Figure 6: A 'snapshot' of vessel traffic detected by the AIS receiver at Unimak Pass. Note that most vessels are heading west.
